Property Address 1234 School House Road  
City Yourtown State US Zip 12345  
Contact Name Ima Goodagent  
Phone (111)-111-1111 Fax (111)-111-1111

Inspector Name Raul Colarte  
Company Name Sentinel Home Inspection Services Inc  
Address 9600 Colerain Ave., Suite 110  
City Cincinnati State OH Zip 45251  
Phone 513-522-7362 Fax 513-729-4683  
E-Mail info@palm-tech.com  
File Number 22222  
Amount Received \$350.00

Others Present Inspector Only Property Occupied Vacant  
Estimated Age 70 Entrance Faces Northwest  
Inspection Date 10/20/2009  
Start Time 9:00am End Time 1:00pm  
Electric On  Yes  No  Not Applicable  
Gas/Oil On  Yes  No  Not Applicable  
Water On  Yes  No  Not Applicable  
Temperature 73 degrees  
Weather Partly cloudy Soil Conditions Dry- No precipitation for past 2 weeks  
Space Below Grade Basement  
Building Type Single family Garage Detached  
Sewage Disposal City How Verified Visual Inspection  
Water Source City How Verified Visual Inspection

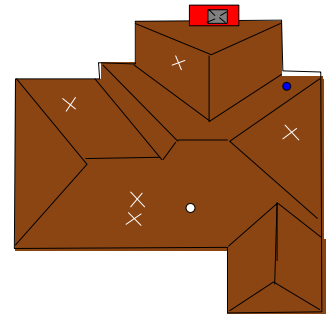
2. Roof Diagram

4.      Material: Fiberglass shingle Nail popping through shingle surface in various locations causing potential water intrusion (see diagram above marked "x")

4. Main Roof Surface Material: Fiberglass shingle **Nail popping through shingle surface in various locations causing potential water intrusion (see diagram above marked "x")**
5. Flashing: Galvanized Metal **Inadequate flashing, prone to possible leaks**
6. Leader/Extension: Leaking **Damaged drain tile piping**

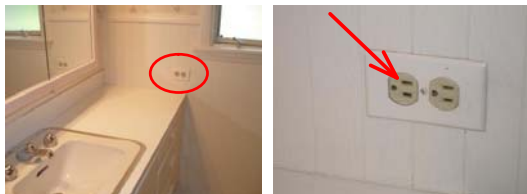
1.      Closet: Single small
2.      Ceiling: Plaster
3.      Walls: Plaster, Ceramic Tile
4.      Floor: Ceramic tile
5.      Doors: Hollow wood
6.      Windows: Wood casement
7.      Electrical: 110 VAC **Non-GFCI circuit, Reversed polarity present**

24. Hall Bathroom Electrical: 110 VAC Non-GFCI circuit, Reversed polarity present

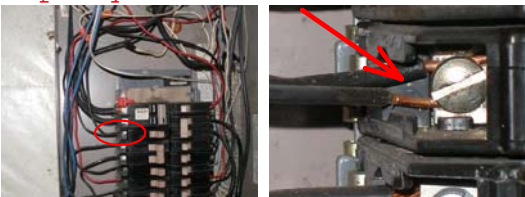
12.      Breakers: Copper **Double taps are present at breakers. These circuits need to be moved to their own circuit breaker and cannot share a breaker. It is recommended that a qualified electrician inspect the new circuits and properly connect the new circuits to an individual breaker for each circuit**

10. Basement Electric Panel Breakers: Copper Double taps are present at breakers. These circuits need to be moved to their own circuit breaker and cannot share a breaker. It is recommended that a qualified electrician inspect the new circuits and properly connect the new circuits to an individual breaker for each circuit

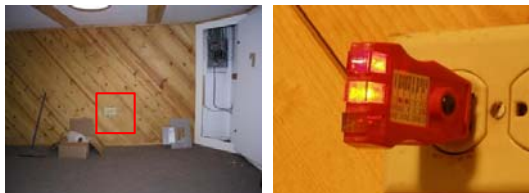
1.      Unable to Inspect: 50% Basement partially finished restricting view
2.      Ceiling: Drywall
3.      Walls: Drywall, Wood Paneling, Plywood Damaged areas noted
4.      Floor: Carpet
5.      Floor Drain: Surface drain
6.      Doors: Hollow wood
7.      Windows: Steel casement
8.      Electrical: 110 VAC Reversed polarity exists at several basement outlets

17. Main Basement Electrical: 110 VAC **Reversed polarity exists at several basement outlets**
